FIRE PERFORMANCE OF EXTERNAL THERMAL INSULATION - CLASSIFICATION REPORT No EFR-19-004382

FIRE PERFORMANCE OF EXTERNAL THERMAL INSULATION CLASSIFICATION IN ACCORDANCE WITH BS 8414-2-2015+A1-2017 and BR 135 third edition 2013.

Classification report No.: EFR-19-004382

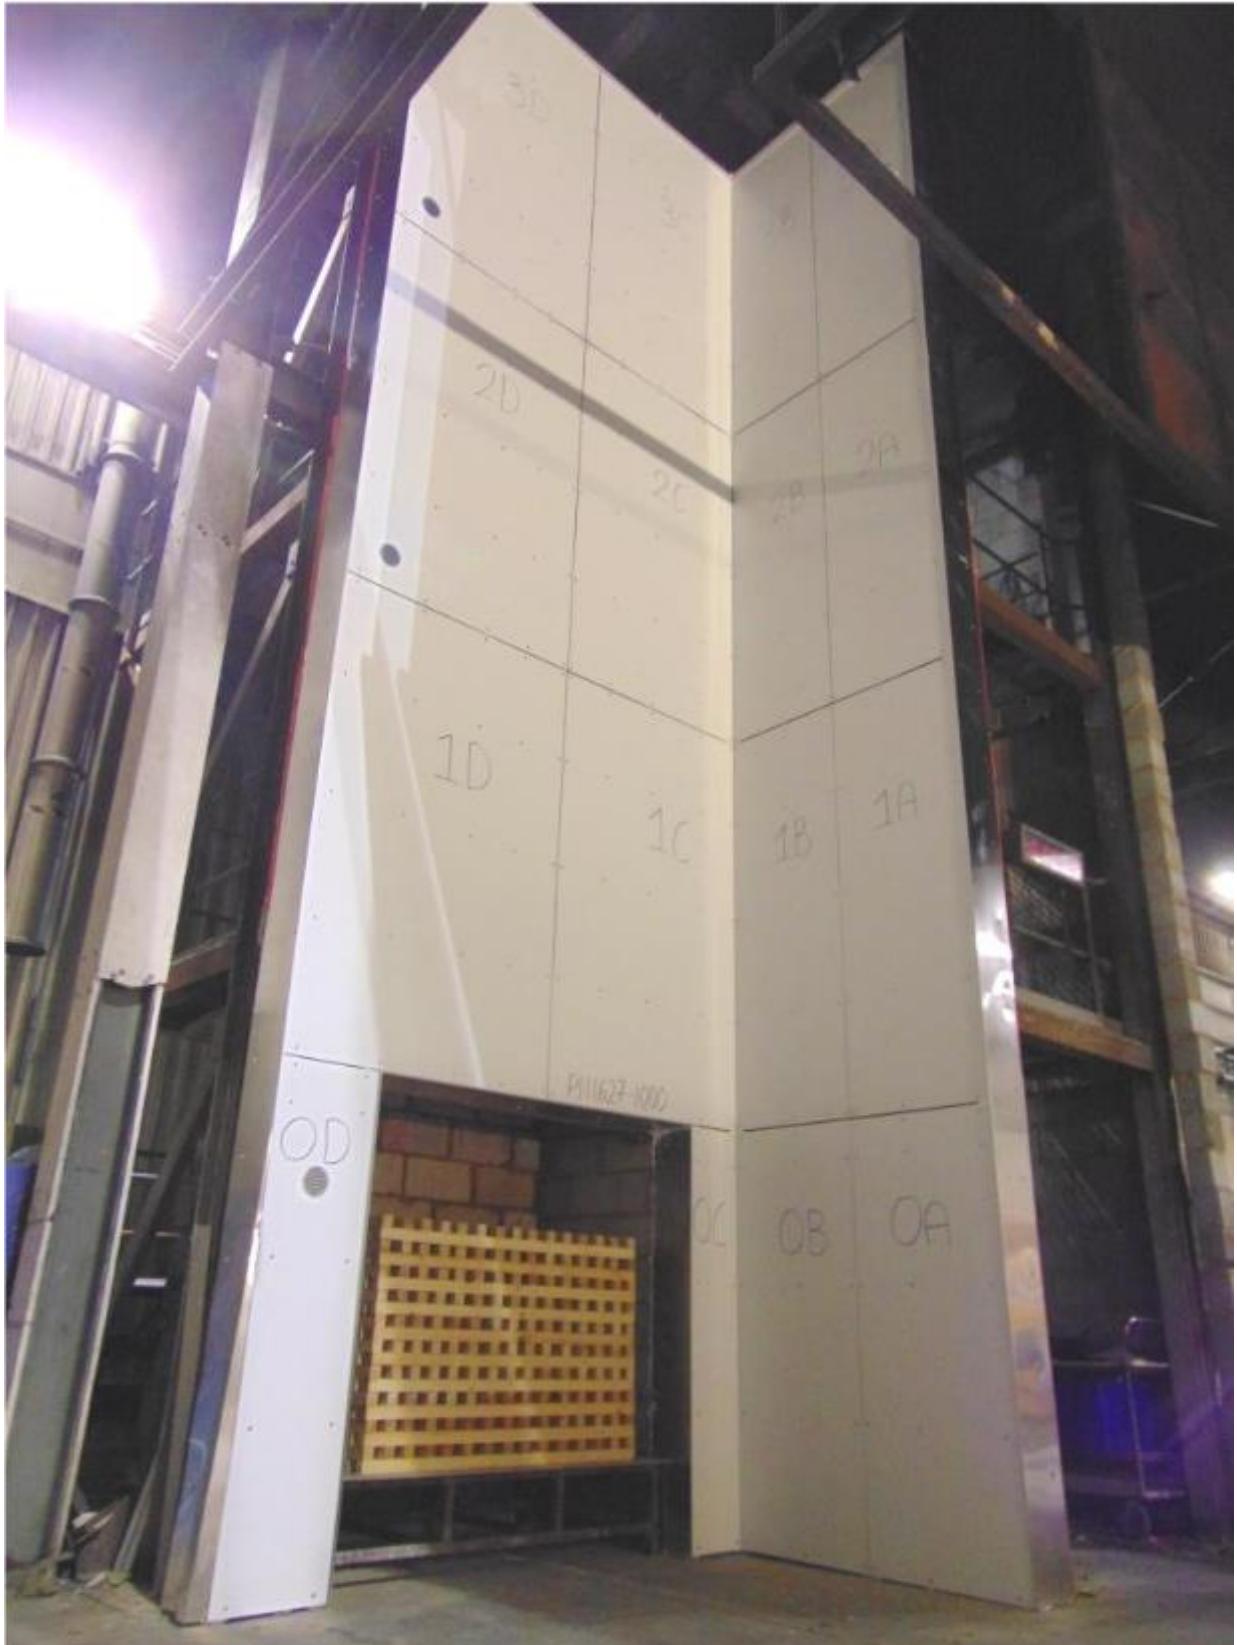
Figure 1. System photos (Main face on the right - Wing face on the left) at the beginning of the test

The system described in this report is a ventilated rainscreen cladding system composed of 100mm thick Rockwool Rainscreen Duo Slab insulation fixed on a lightweight steel frame system. The rainscreen cladding system is made of Vitradual solid aluminium installed on aluminium rails.

Vitradual aluminium panels, long edge vertical, were fixed to the rails using 4.8mm-diameter rivets at 300-440mm horizontal and 150-600mm vertical centres.
