Technical Report – R20933

CWCT – Standard for systemised building envelopes – 2005

Fairview Europe Ltd
Fibre Cement Cladding Panel

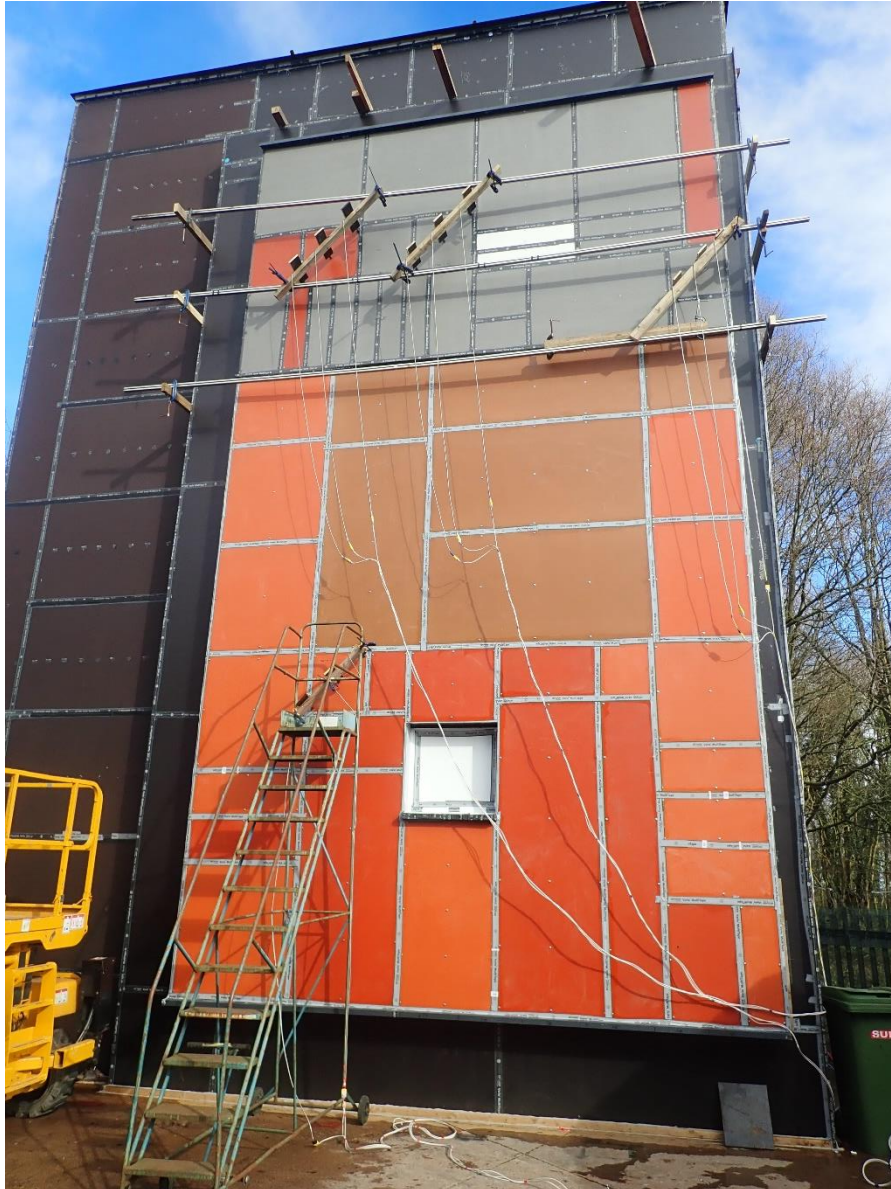
Photograph No. 1

Sample during testing

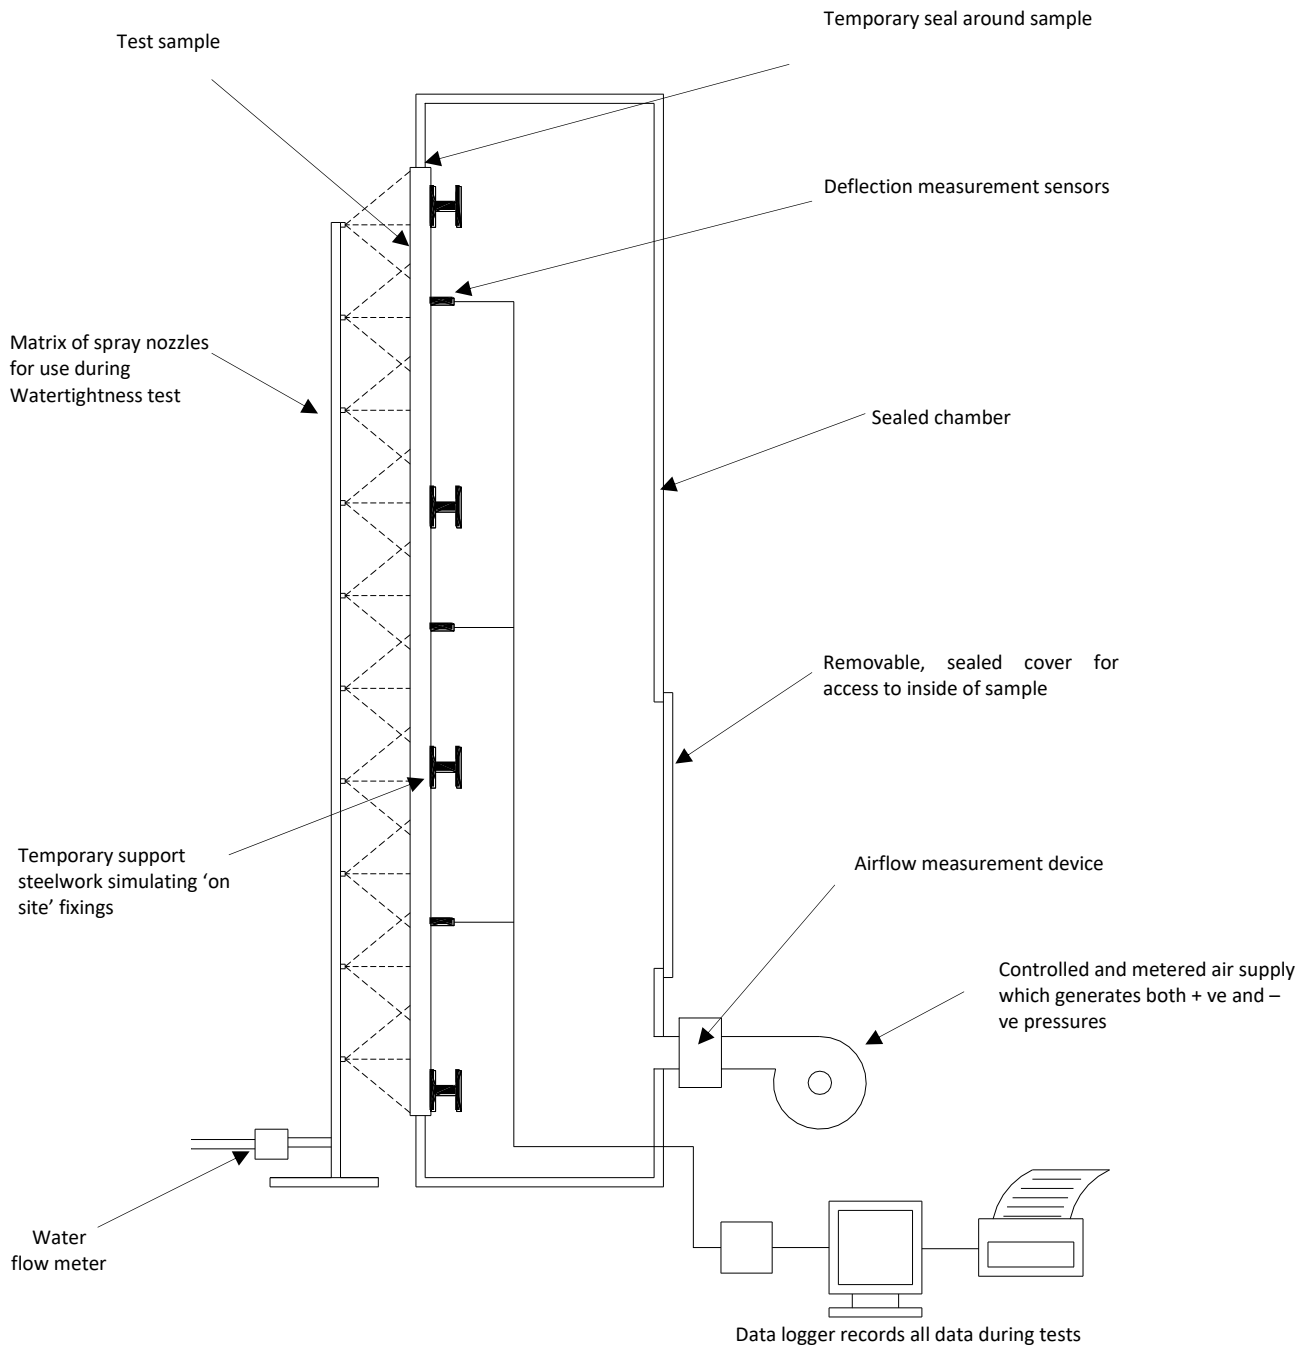
Figure 1 – Test arrangement

A specimen, supplied for testing in accordance with CWCT requirements, was mounted on to a rigid test chamber constructed from steel, timber and plywood sheeting.

The pressure within the chamber was controlled by means of a centrifugal fan and a system of ducting and valves. The static pressure difference between the outside and inside of the chamber was measured by means of a differential pressure transmitter.

General Arrangement of a Typical Test Assembly

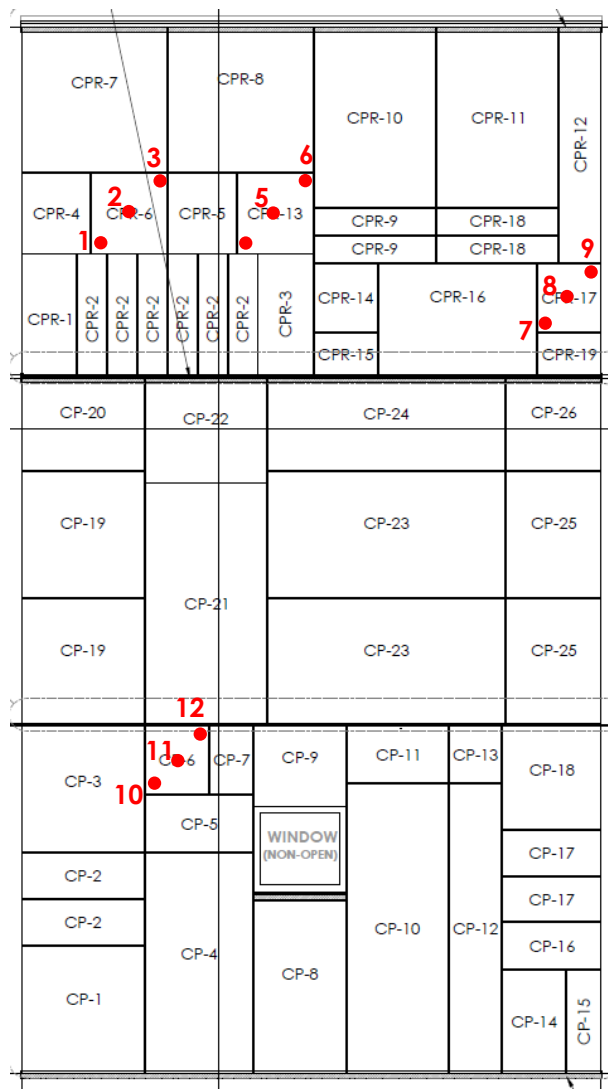
Figure 2

Probe Group Identification	Calculation of deflection
Group A comprised of probes 1, 2 & 3	= Probe 2 – ((Probe 1 + Probe 3)/2)
Group B comprised of probes 4, 5 & 6	= Probe 5 – ((Probe 4 + Probe 6)/2)
Group C comprised of probes 7, 8 & 9	= Probe 8 – ((Probe 7 + Probe 9)/2)
Group D comprised of probes 10, 11 & 12	= Probe 11 – ((Probe 10 + Probe 12)/2)

Positions of Deflection Measurement Probes

View from Outside
Not to Scale

- Deflection probe position

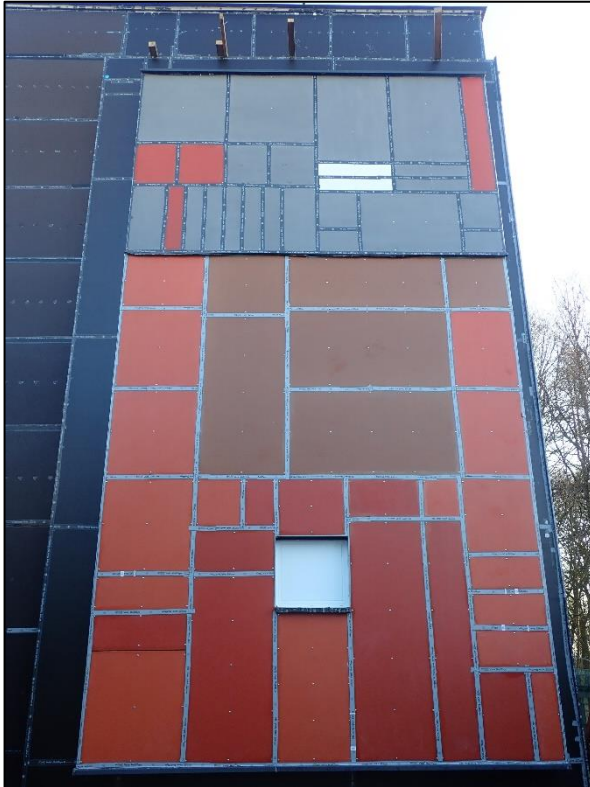
Photograph No. 2

Sample prior to dismantle

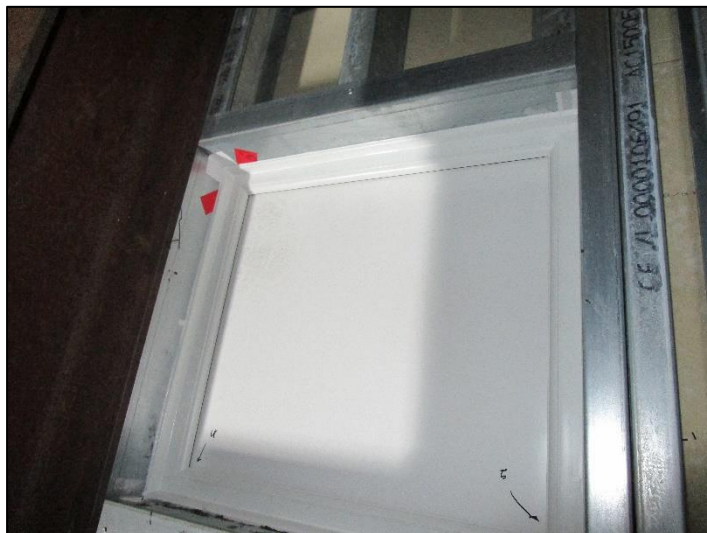
Photograph No. 3

Internal window pod detail

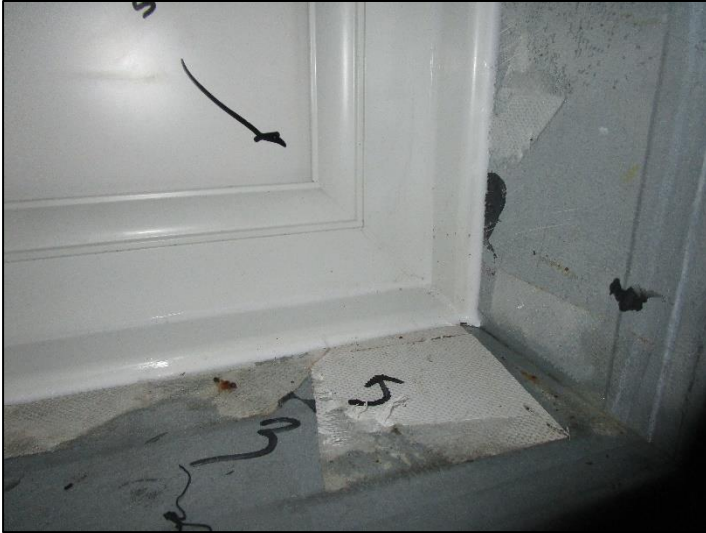
Photograph No. 4

Internal window pod detail

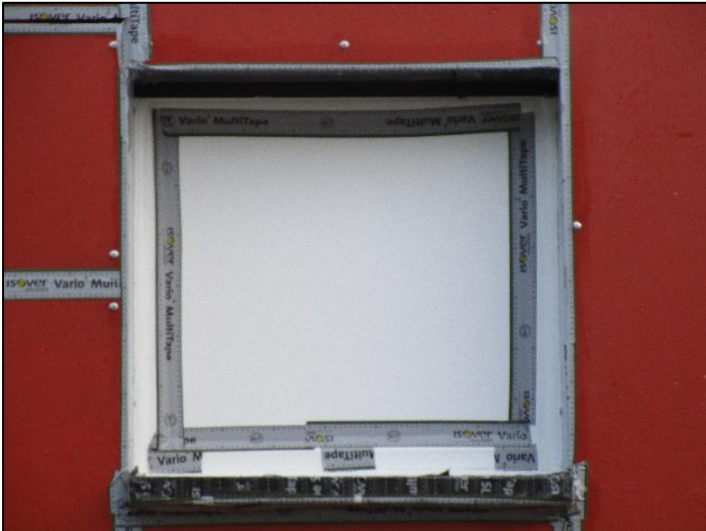
Photograph No. 5

External window pod detail

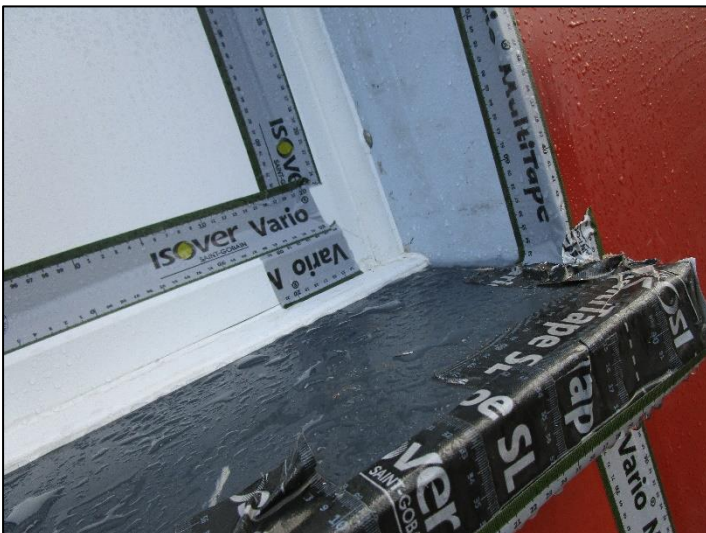
Photograph No. 6

Window pod interface detail

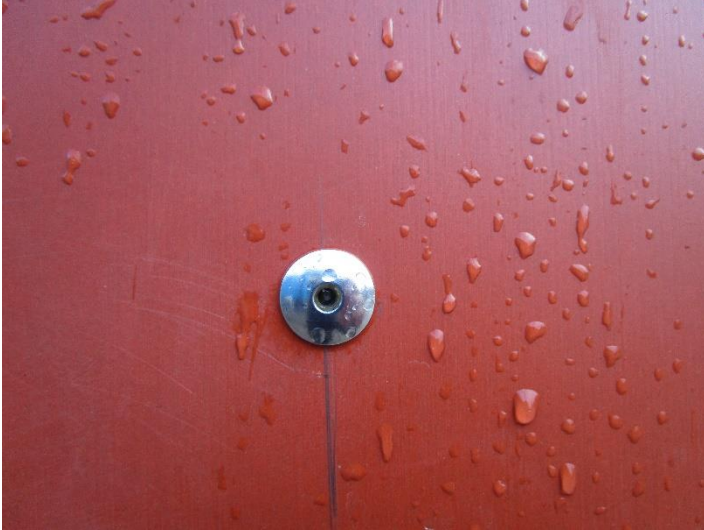
Photograph No. 7

Rivet fixing

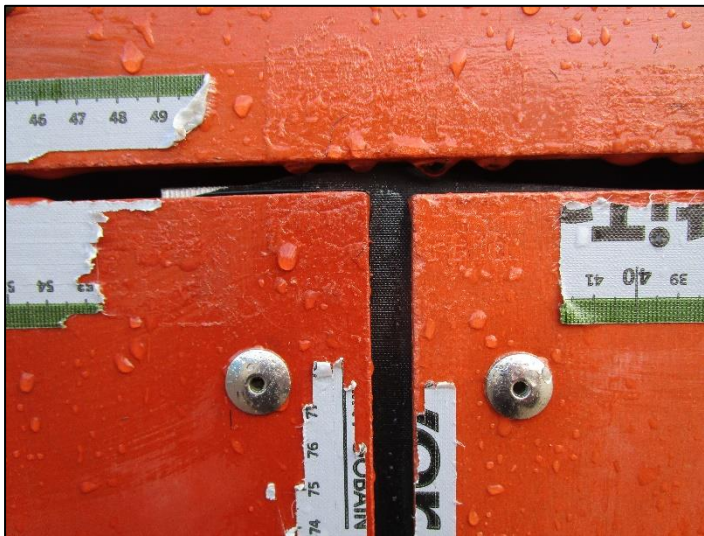
Photograph No. 8

Typical joint between panels

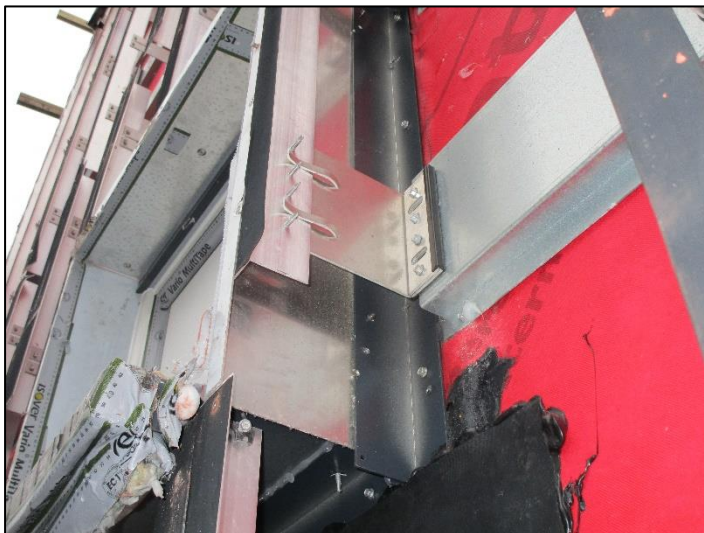
Photograph No. 9

Rail, helping hand and window pod detail

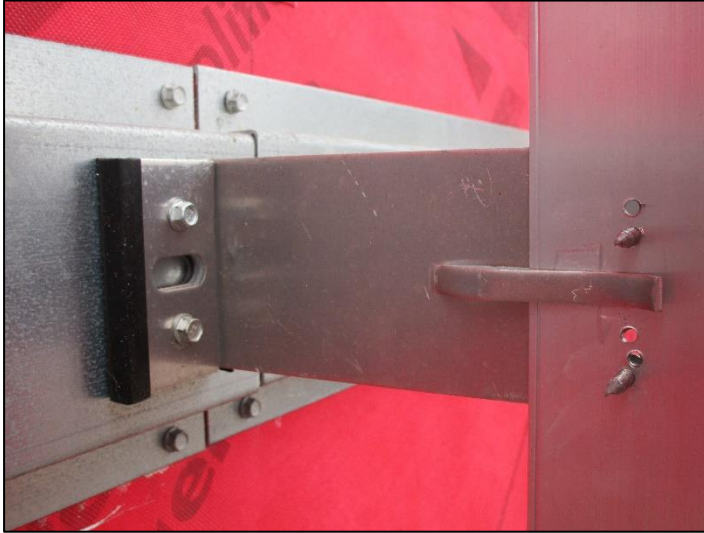
Photograph No. 10

Helping hand and rail detail

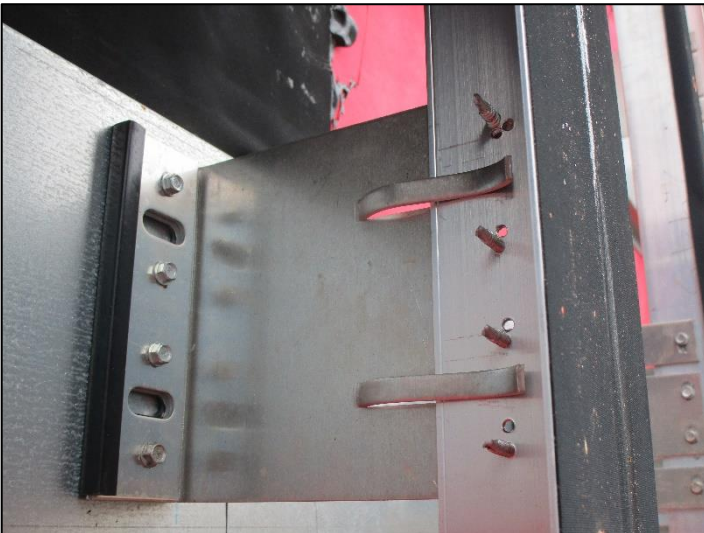
Photograph No. 11

Helping hand and rail detail

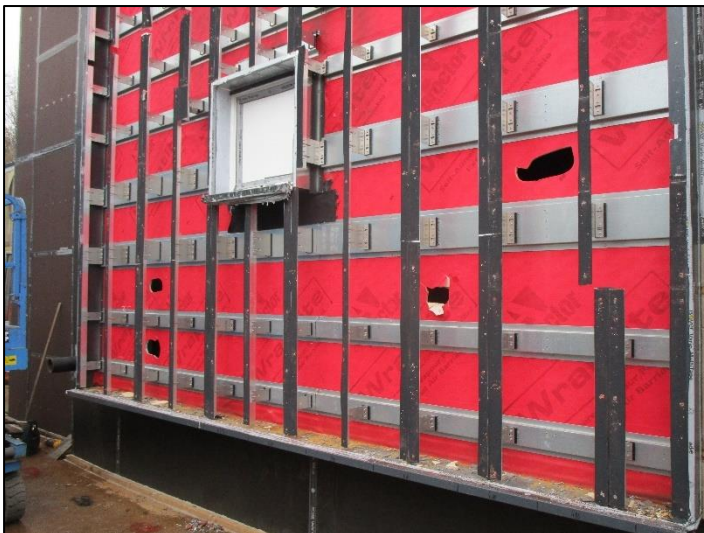
Photograph No. 12

Rail layout on bottom section of sample

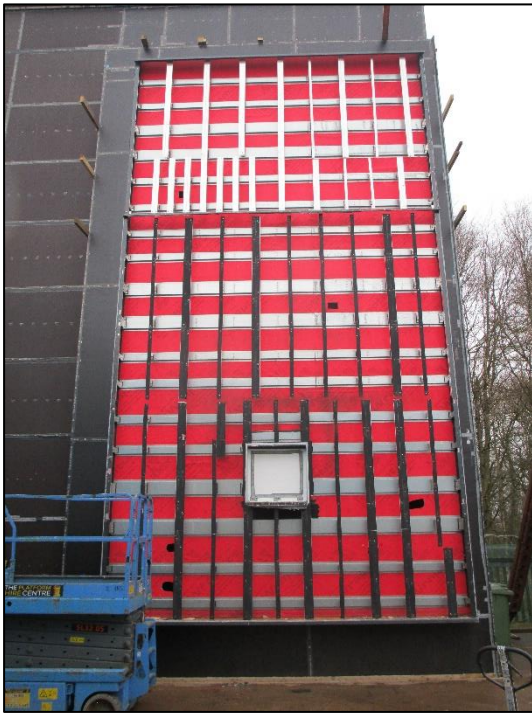
Photograph No. 13

Full rail layout

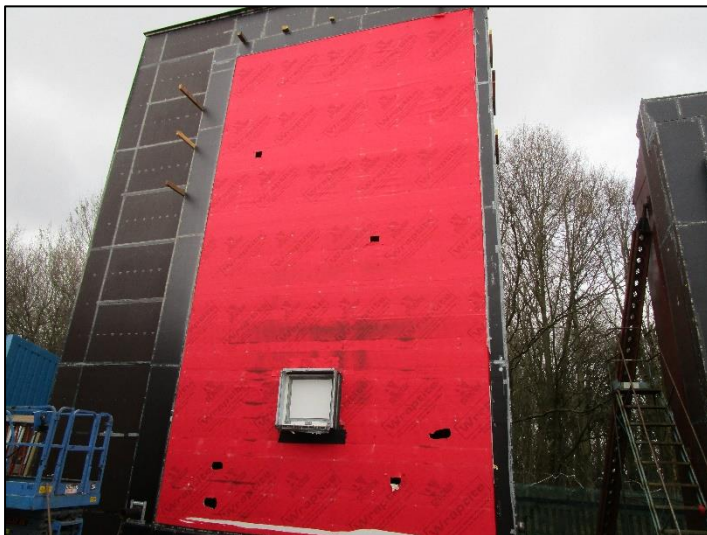
Photograph No. 14

Backing wall detail

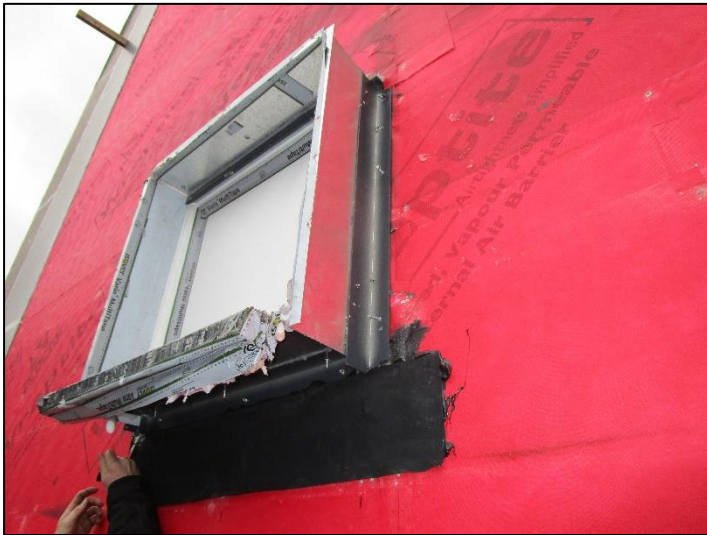
Photograph No. 15

Backing wall and window pod detail, not as per drawings reference 1508-4201 Rev AB, 1508-3001 Rev AB and 1508-4204 Rev AB

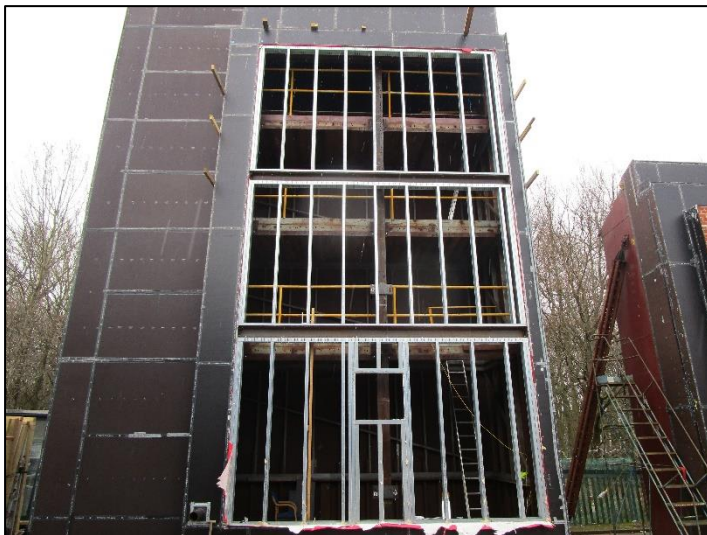
Photograph No. 16

Metsec layout
